Development of Inspection Technology for NGV Fuel Tanks

Failure Analysis Associates, Inc.
Menlo Park, California

General Motors Corporation
Research & Development Center
Warren, Michigan

May 1997
(Revised August 1997)

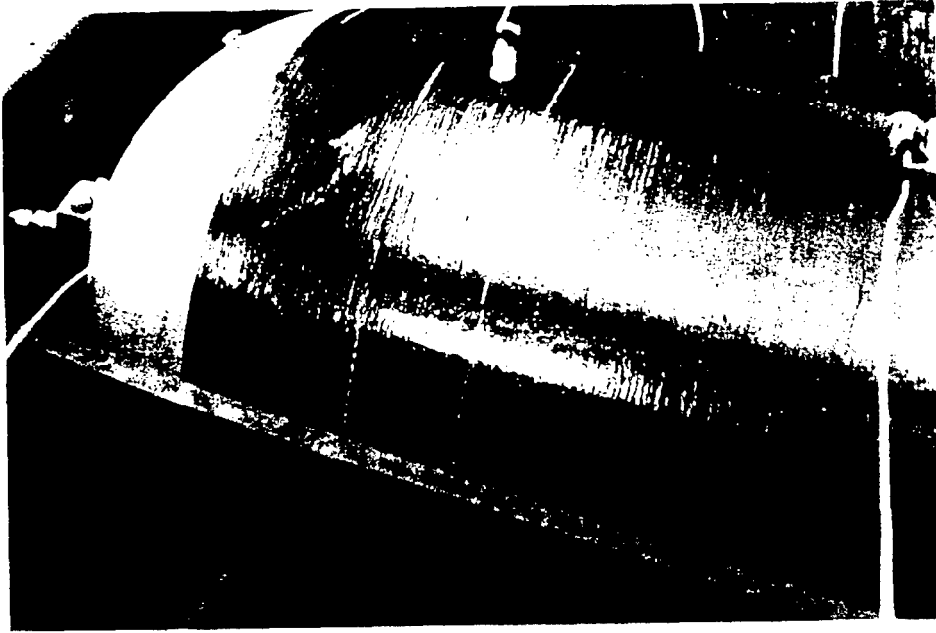
Figure 47. Circumferential Cracks Propagating from the Ends of the 2-inch Slit

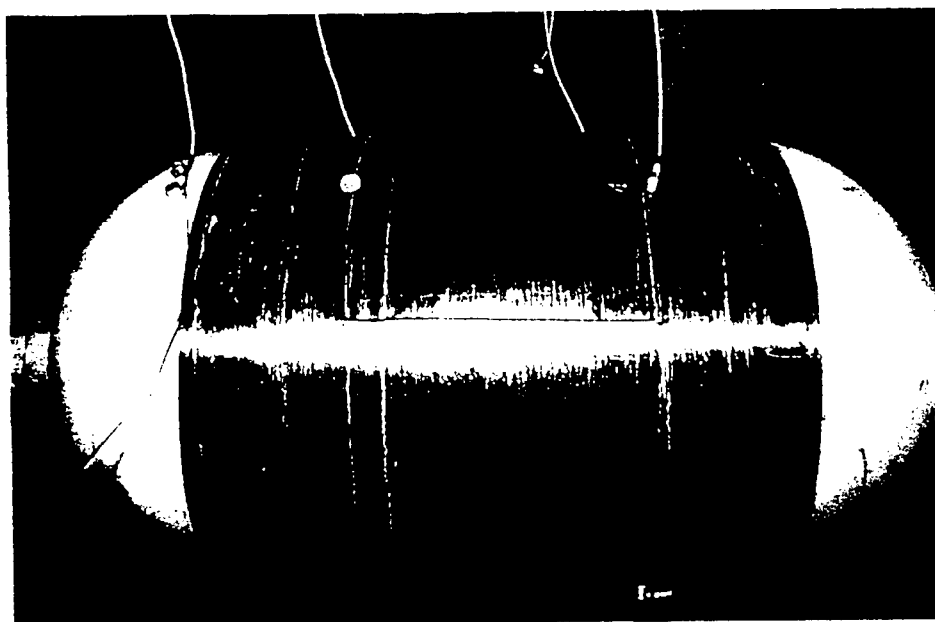
Figure 67. Circumferential Cracks at the Ends of the 8-inch Slit in Tank 018

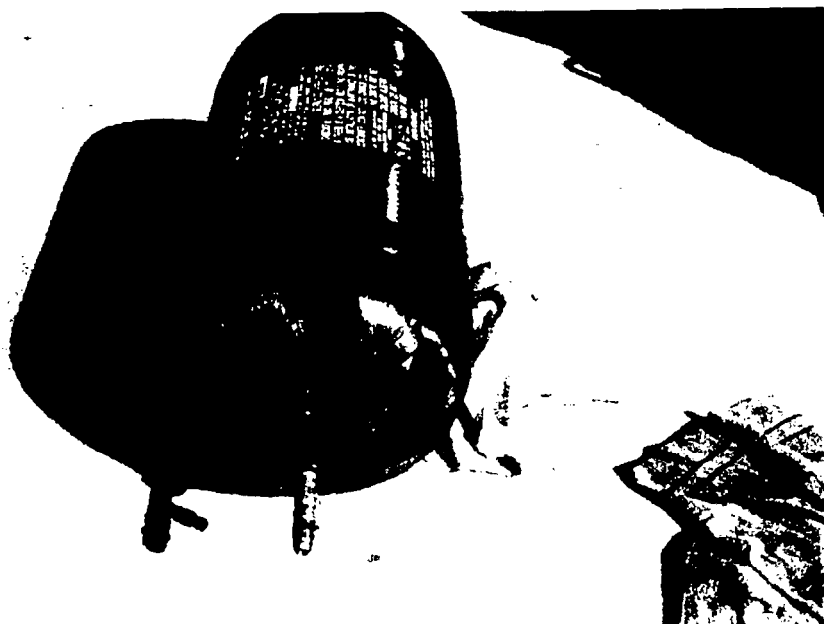
Condition	Significant AE Pressure, psig	Observations
Virgin	6,062	No visible change
Impact 45° Drop c.g., 5 ft above concrete	3,667	No visible change
Fatigue 6,000 cycles - 3,600 psig* 2,146 cycles - 4,000 psig	4,500	Tank failed at impact site after 8,146 cycles

Figure 84. Failed Area on Tank 003
